PROJECT PROFILE

ELASTOSPRAY® Roofing System

30 years of severe weather resistance

- Mississippi Coast Coliseum, a 24,780-square-foot, domed stadium

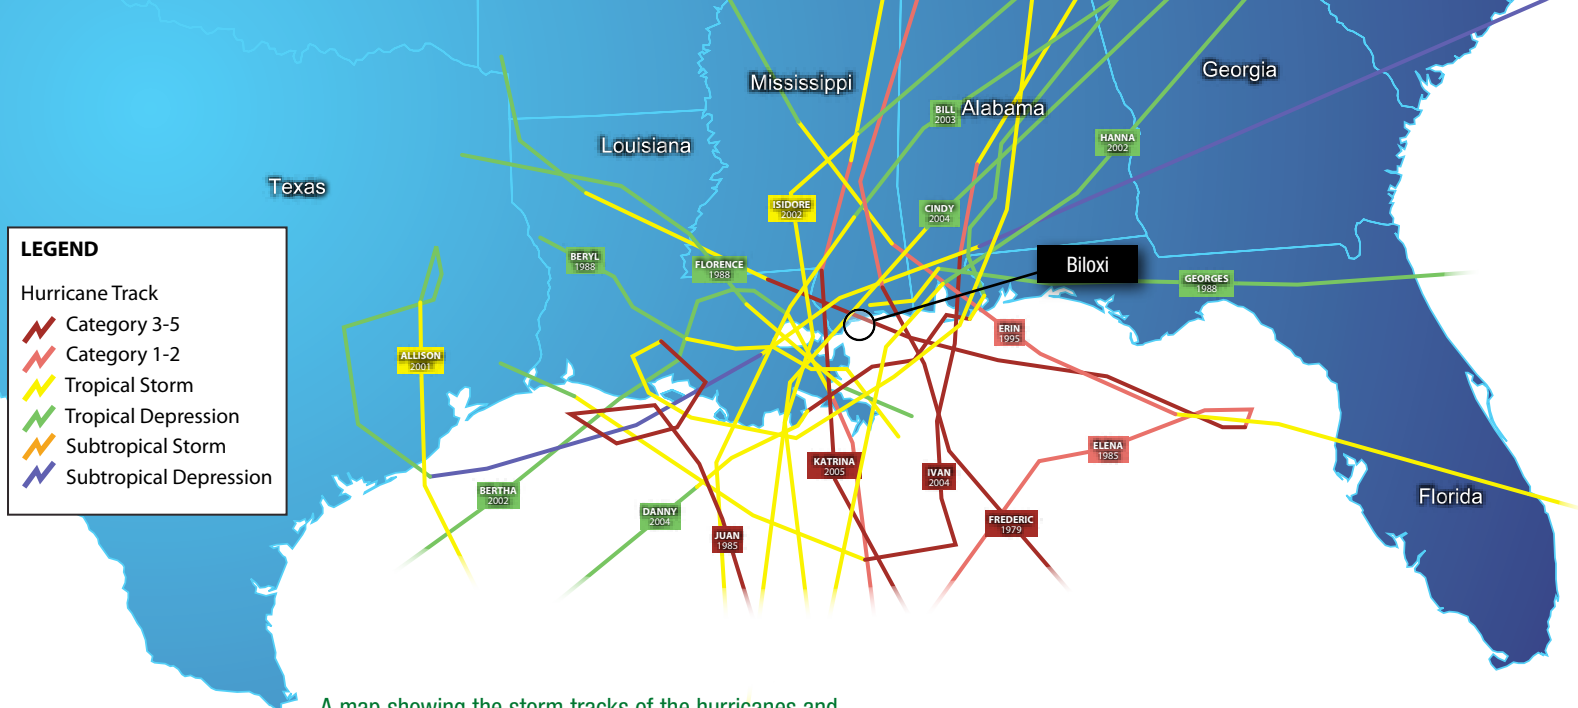
A map showing the storm tracks of the hurricanes and tropical storms that have occurred in Biloxi from 1979 to 2005.
<http://maps.csc.noaa.gov/hurricanes/viewer.html>

It turns out Mississippi Coast Coliseum has a long history of surviving storms. NOAA Coastal Services Center records show 15 named hurricanes and tropical storms hitting Biloxi from 1979 to 2005 (see Table 1). The highest wind speed tracked was 115 miles per hour (mph) during Hurricane Frederic in 1979. Hurricane Katrina brought wind speeds as high as 110 mph to Biloxi.

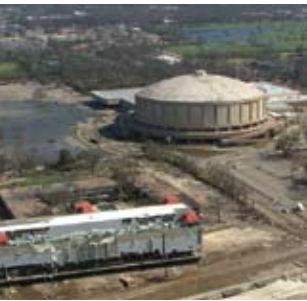
The Biloxi Coliseum stands strong after facing Hurricane Katrina.

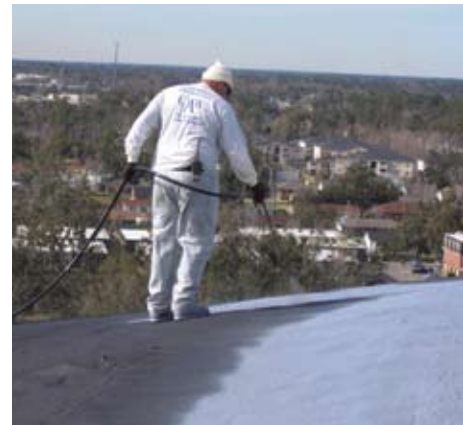
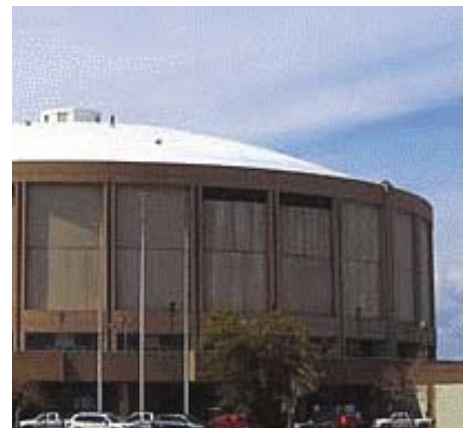
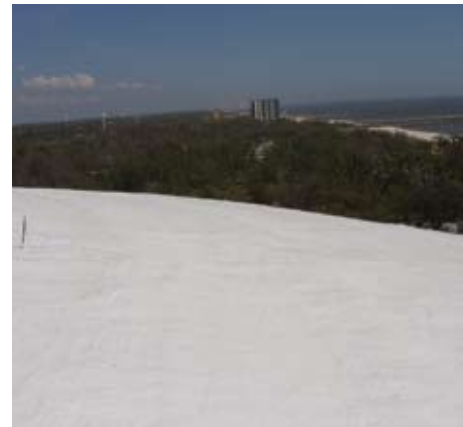
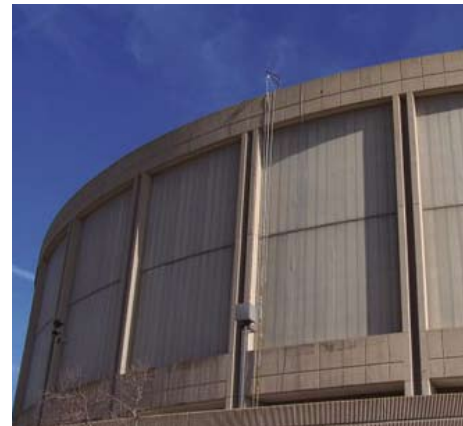
Rothlingsberger and his team performed a careful assessment of the damage to the coliseum’s roof, and then set to work on the repairs. One-half-inch of the original polyurethane foam was scarfed down and removed, and then a fresh application of one-inch thick ELASTOSPRAY spray-applied polyurethane foam was installed. The project was
